An Taisce
The National Trust for Ireland

Buildings at Risk

November 2014

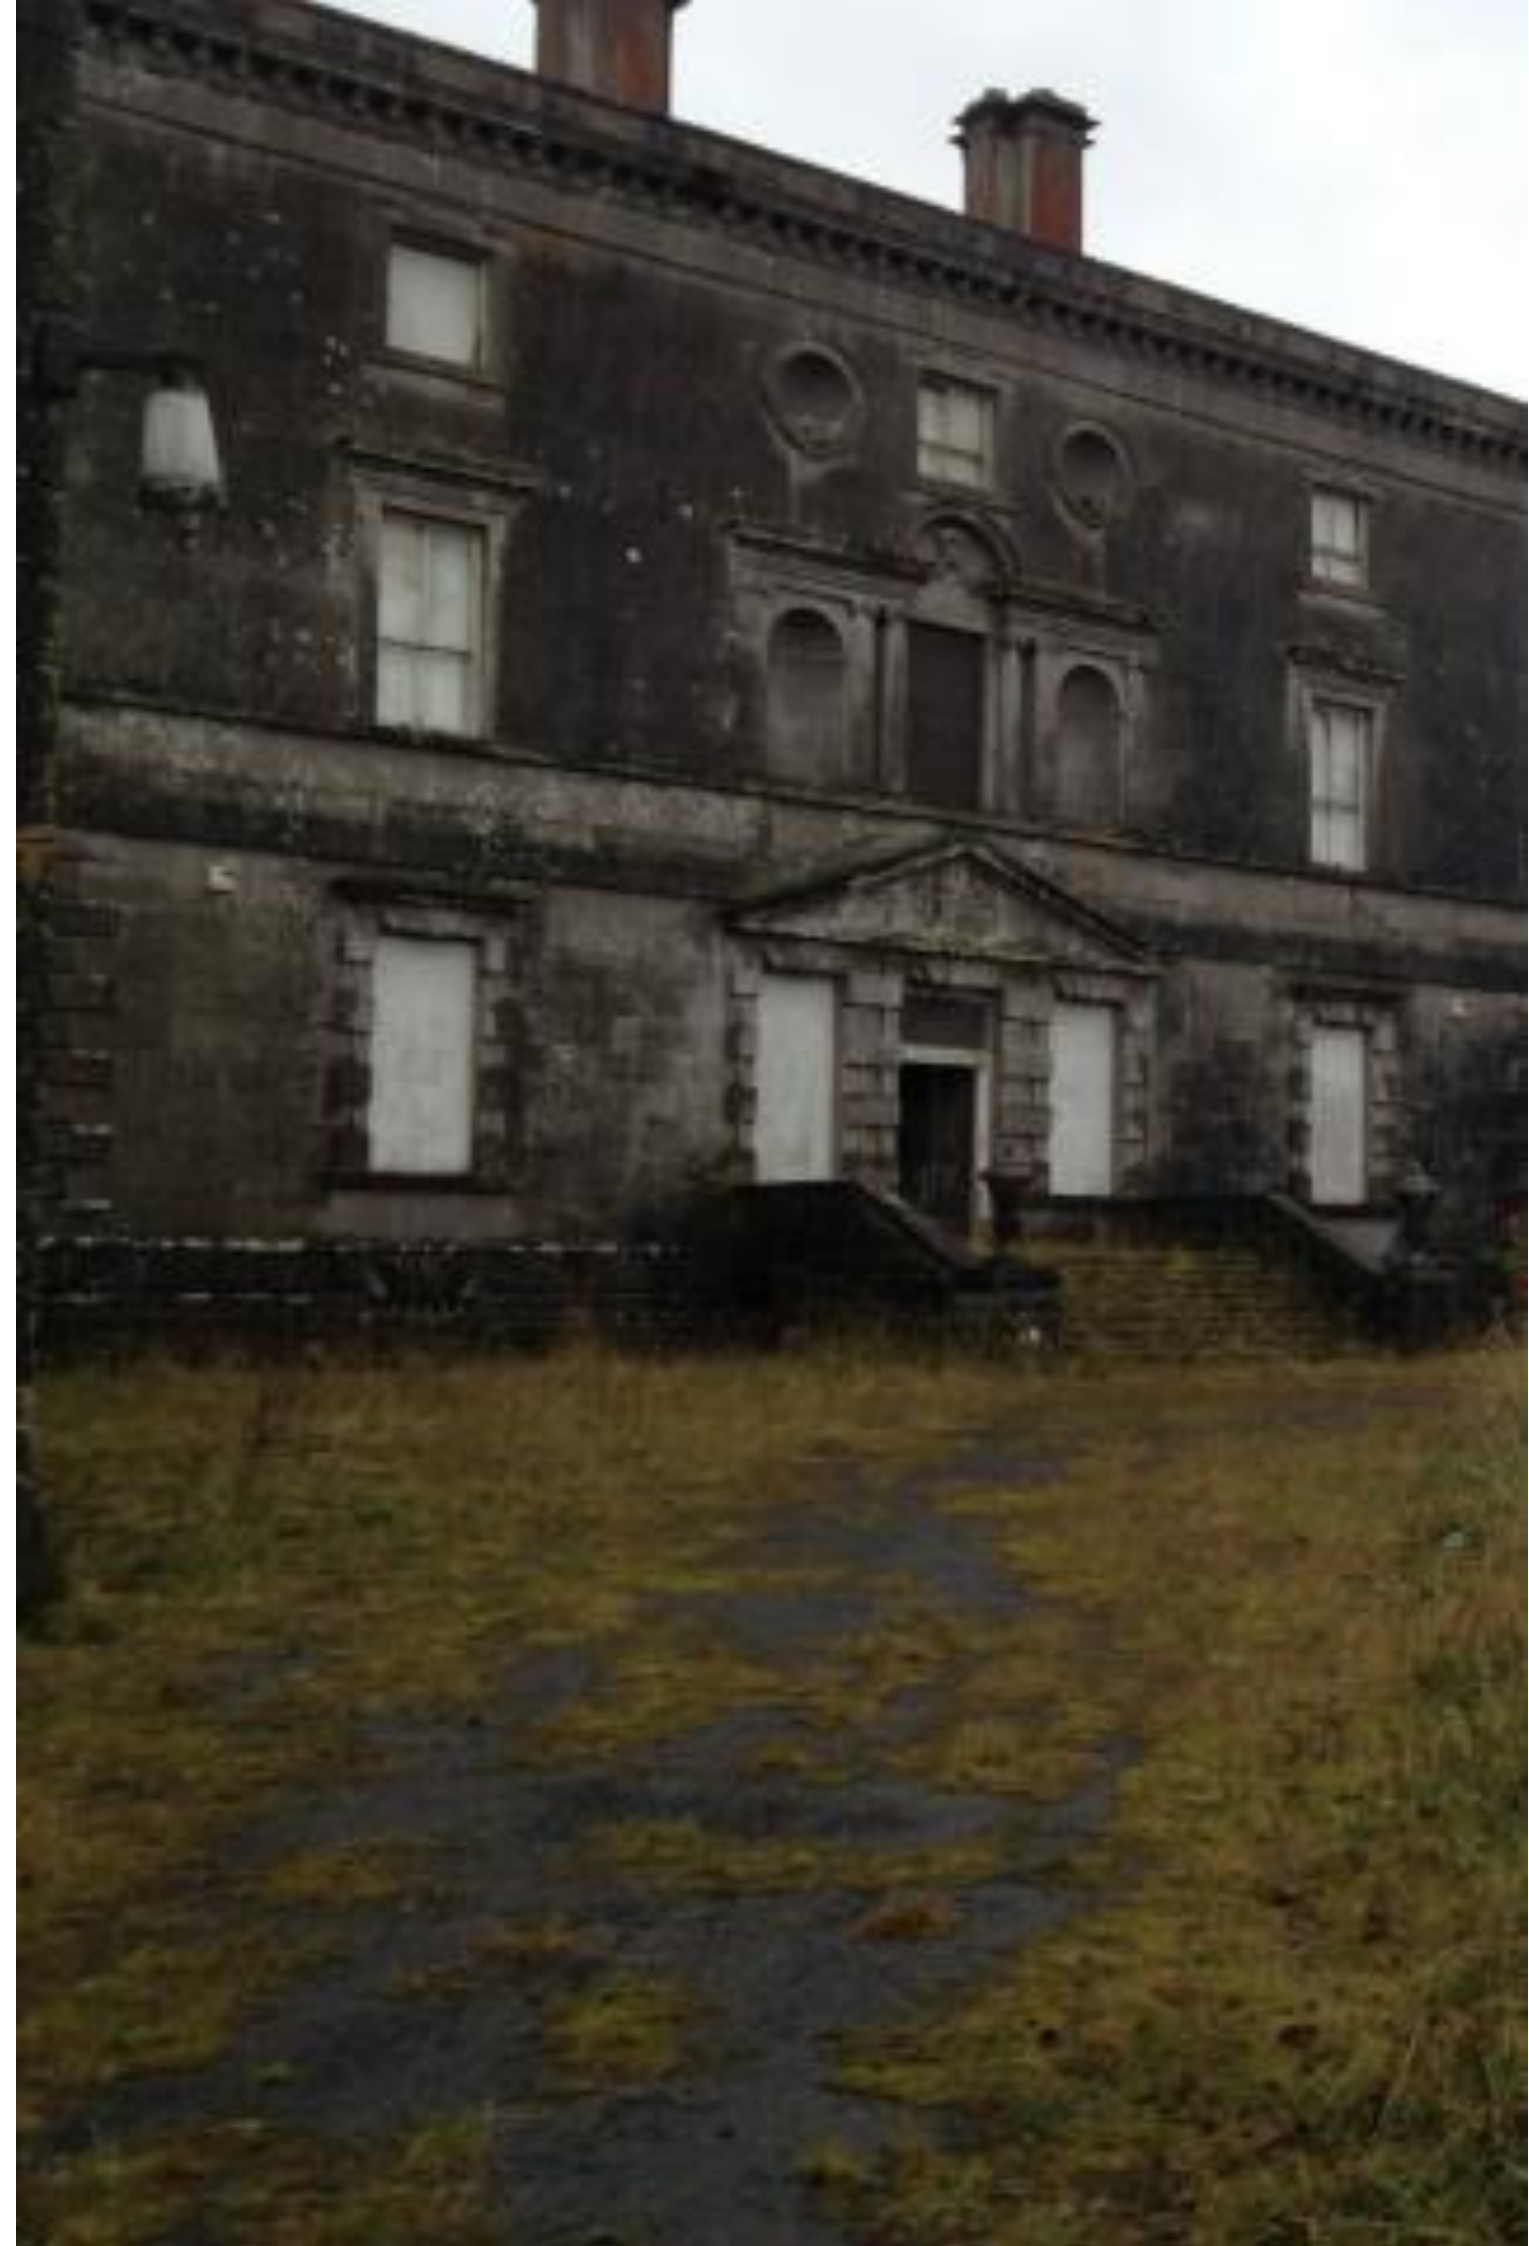
The Barracks

The five-bay, three-storey former barracks building, with two storey wings either side was built in 1730. It is constructed with rendered limestone. Despite its advanced state of dereliction, many original features survive, including slate roof and timber sash windows. The building has been vacant for a number of years with sections of the roof having recently collapsed which has exposed the interior to weather damage. Having been vacated by the Army, it is currently in Council's ownership. This building urgently requires new uses to be identified to prevent further deterioration of its character.

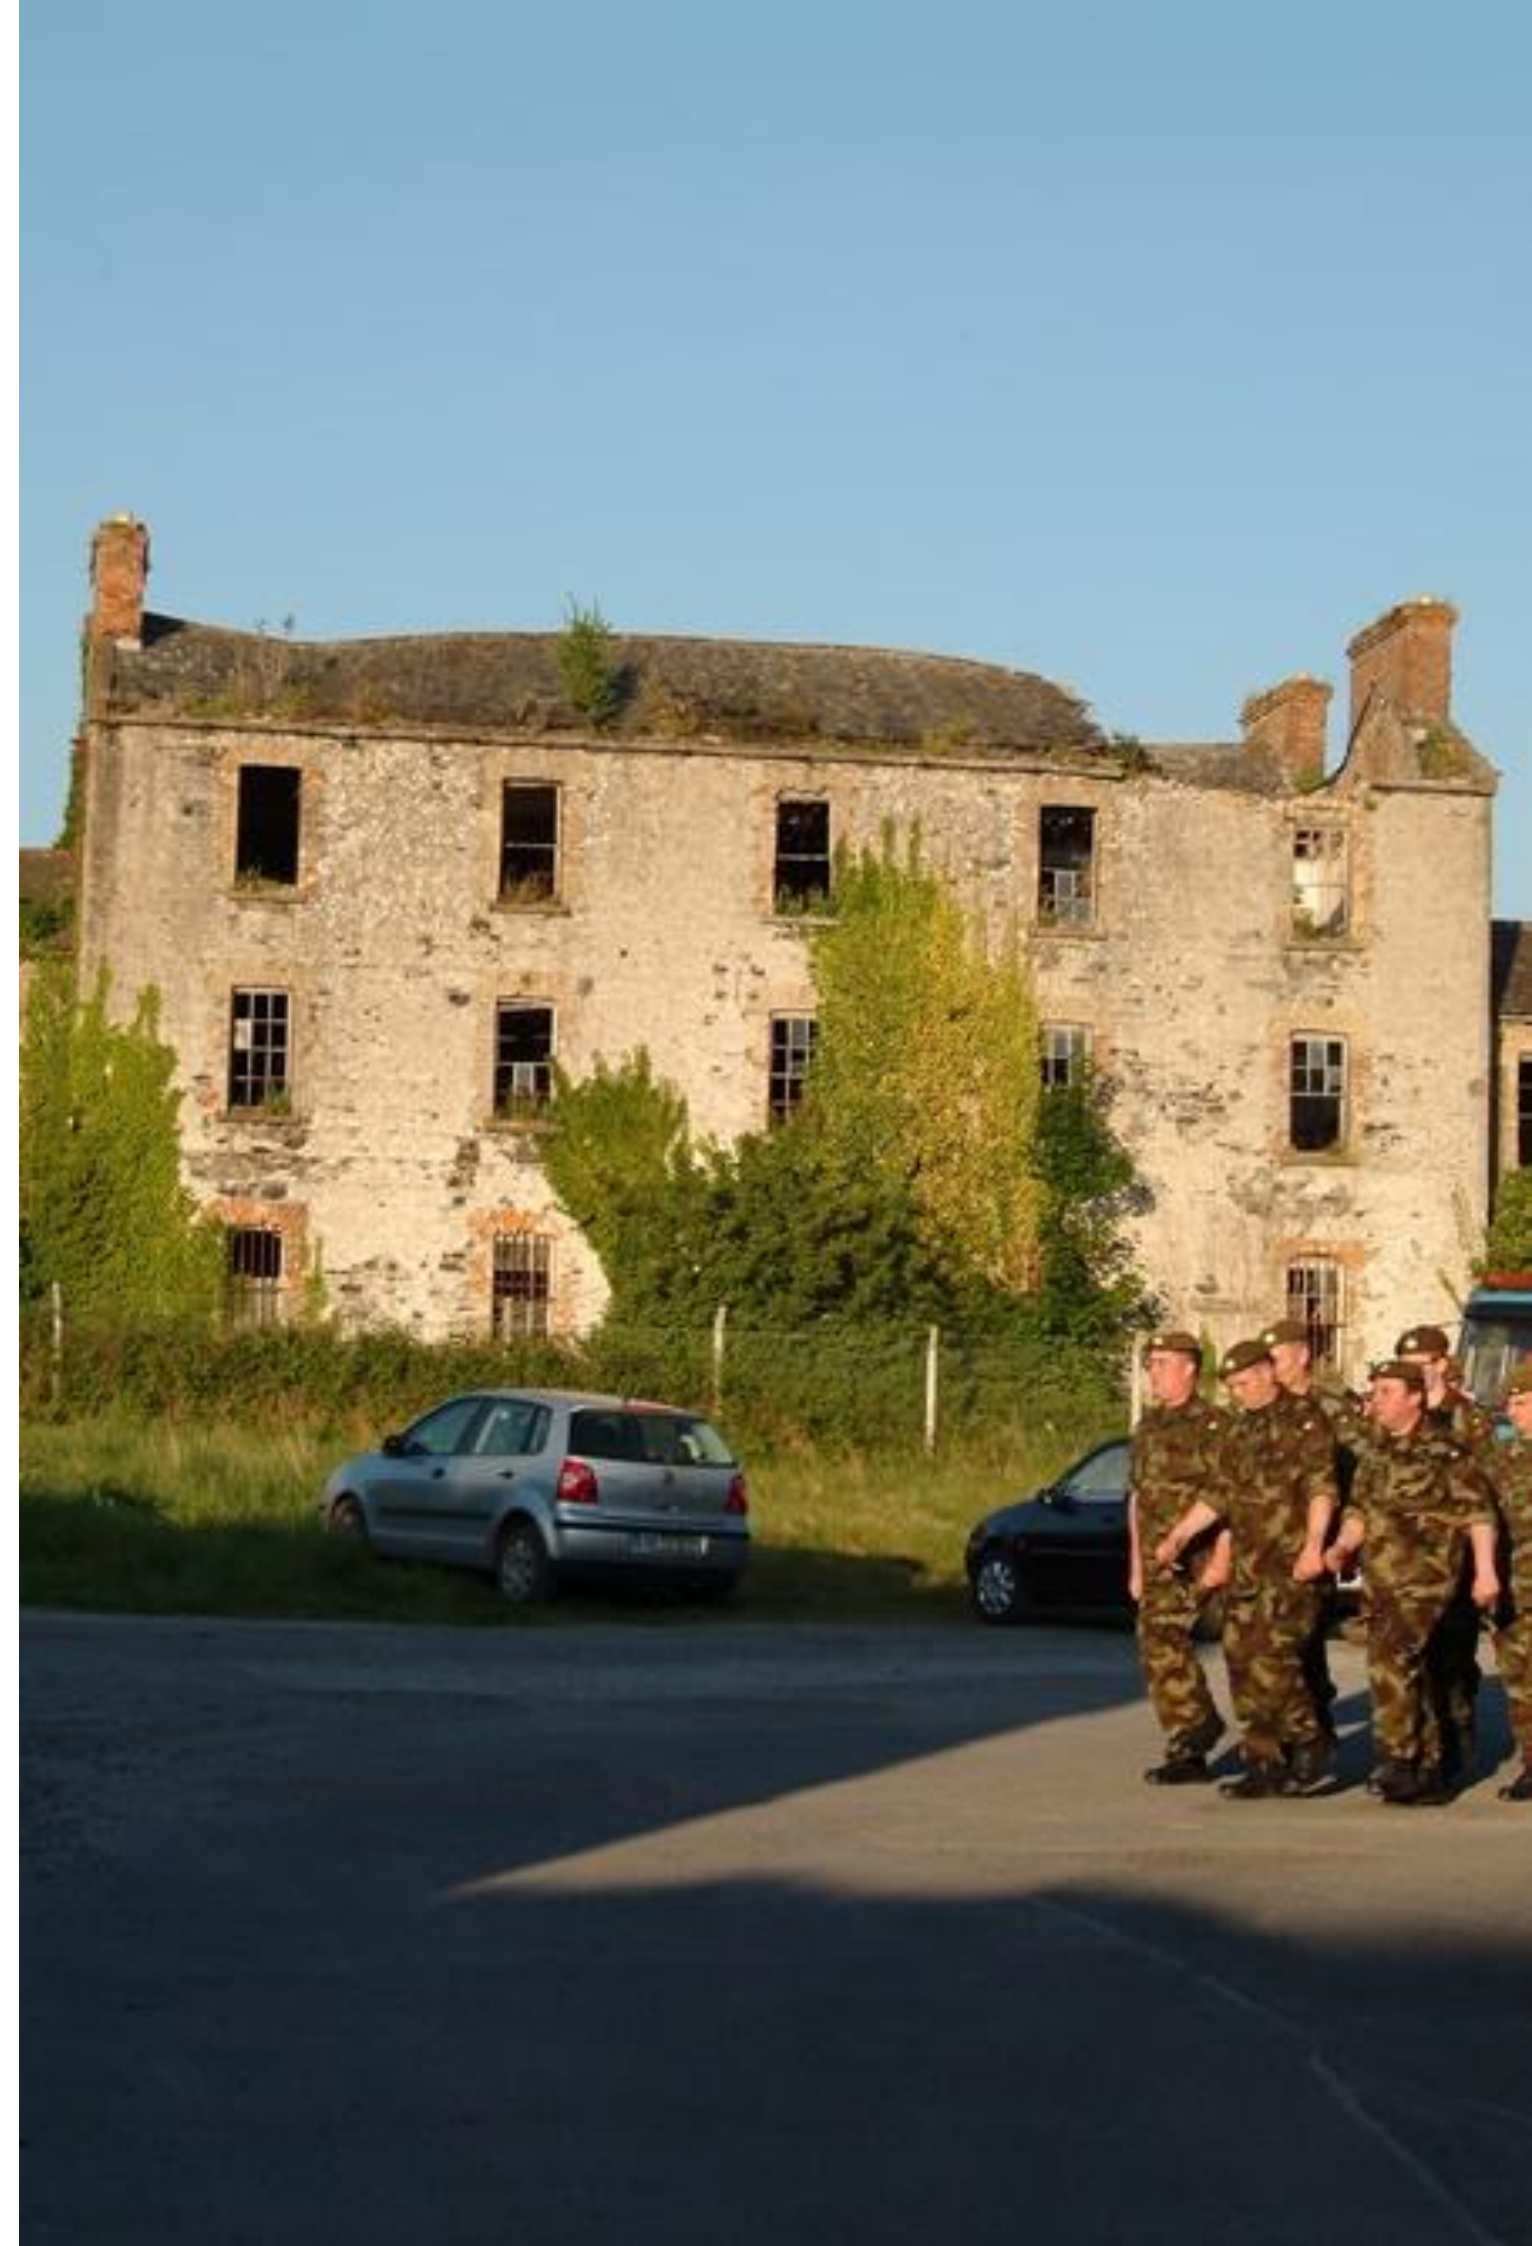
Thomastown Castle

The atmospheric ruin of the great seat of the Mathews, now largely shrouded in ivy. Central block was a 17th century house constructed by George Mathew, half brother of the 1st Duke of Ormond, now largely collapsed. Building dramatically altered in the early 19th century with new wings and four slender towers to front by Richard Morrison. House was childhood home of Father Theobald Mathew, "The Apostle of Temperance". The fortunes of the family declined and house fell into ruin by the late 19th century. Surrounding it are the remains of the 17th century formal gardens overlaid by 19th century work. Consolidation is now required to arrest further deterioration of the ruin.

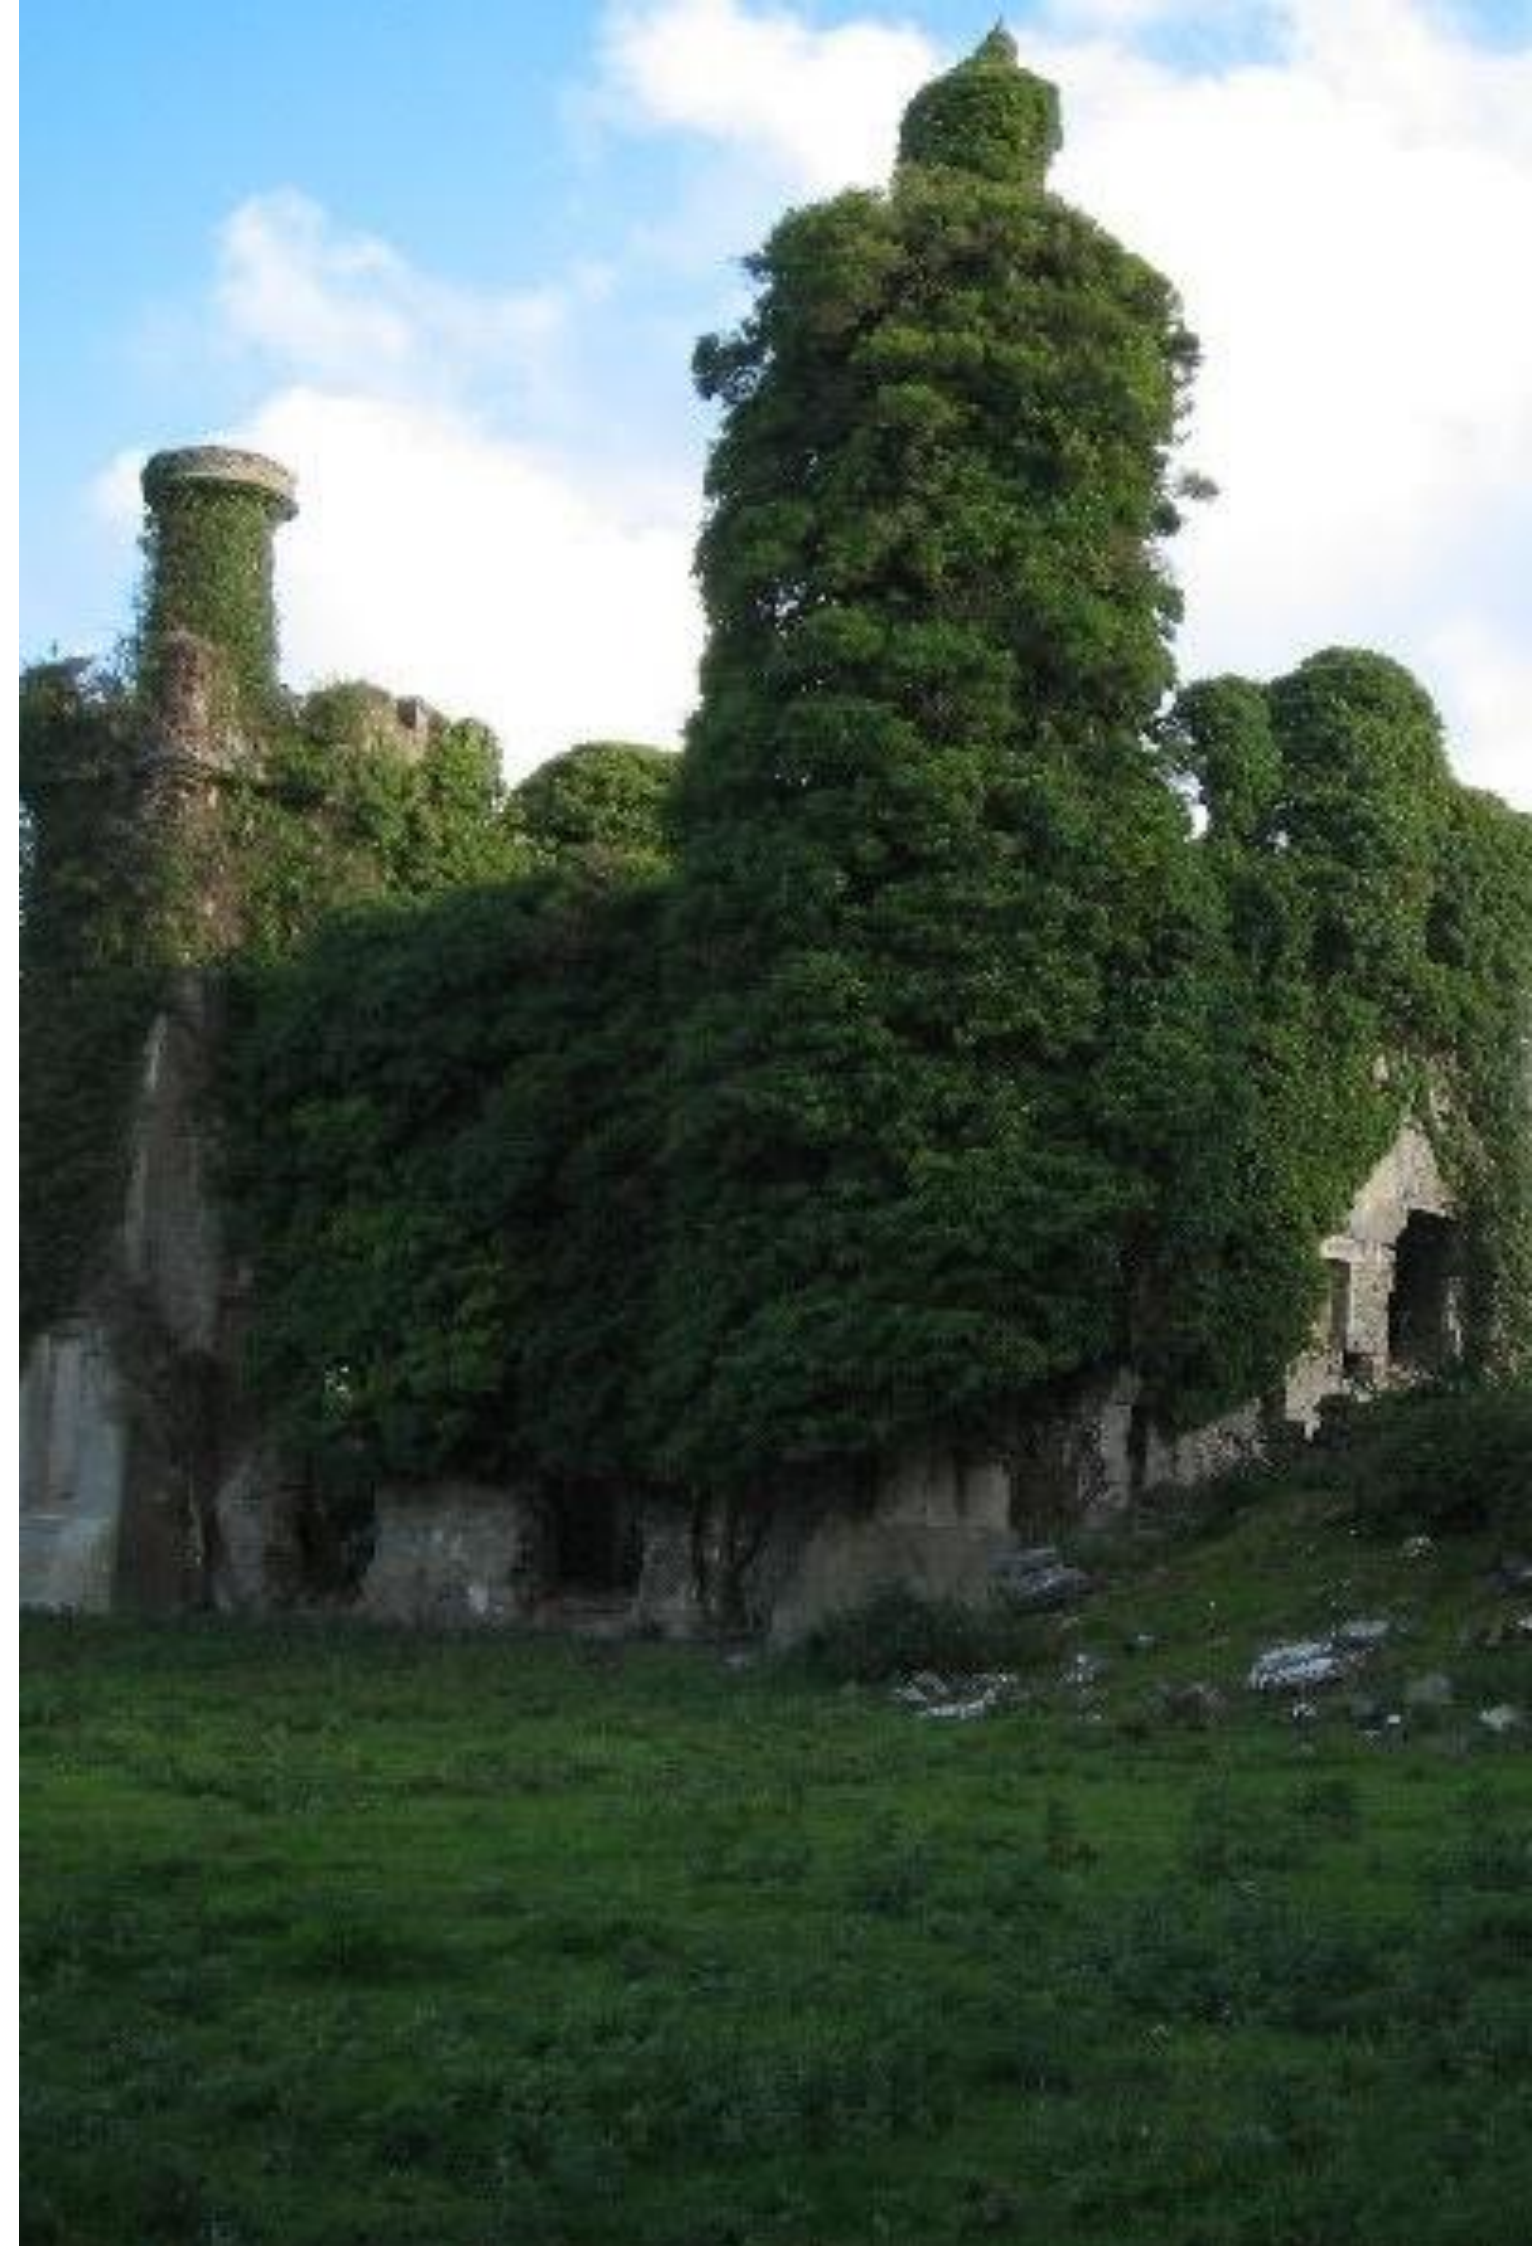
Ballygunner Castle

The country house is on the site of an earlier medieval castle. The building is rated as being of national importance in the National Inventory Architectural Heritage due to the 'massing of the house, together with the informal arrangement of the openings' which is considered to resemble the earlier castle. This building urgently requires new uses to be identified to prevent further deterioration of its character.

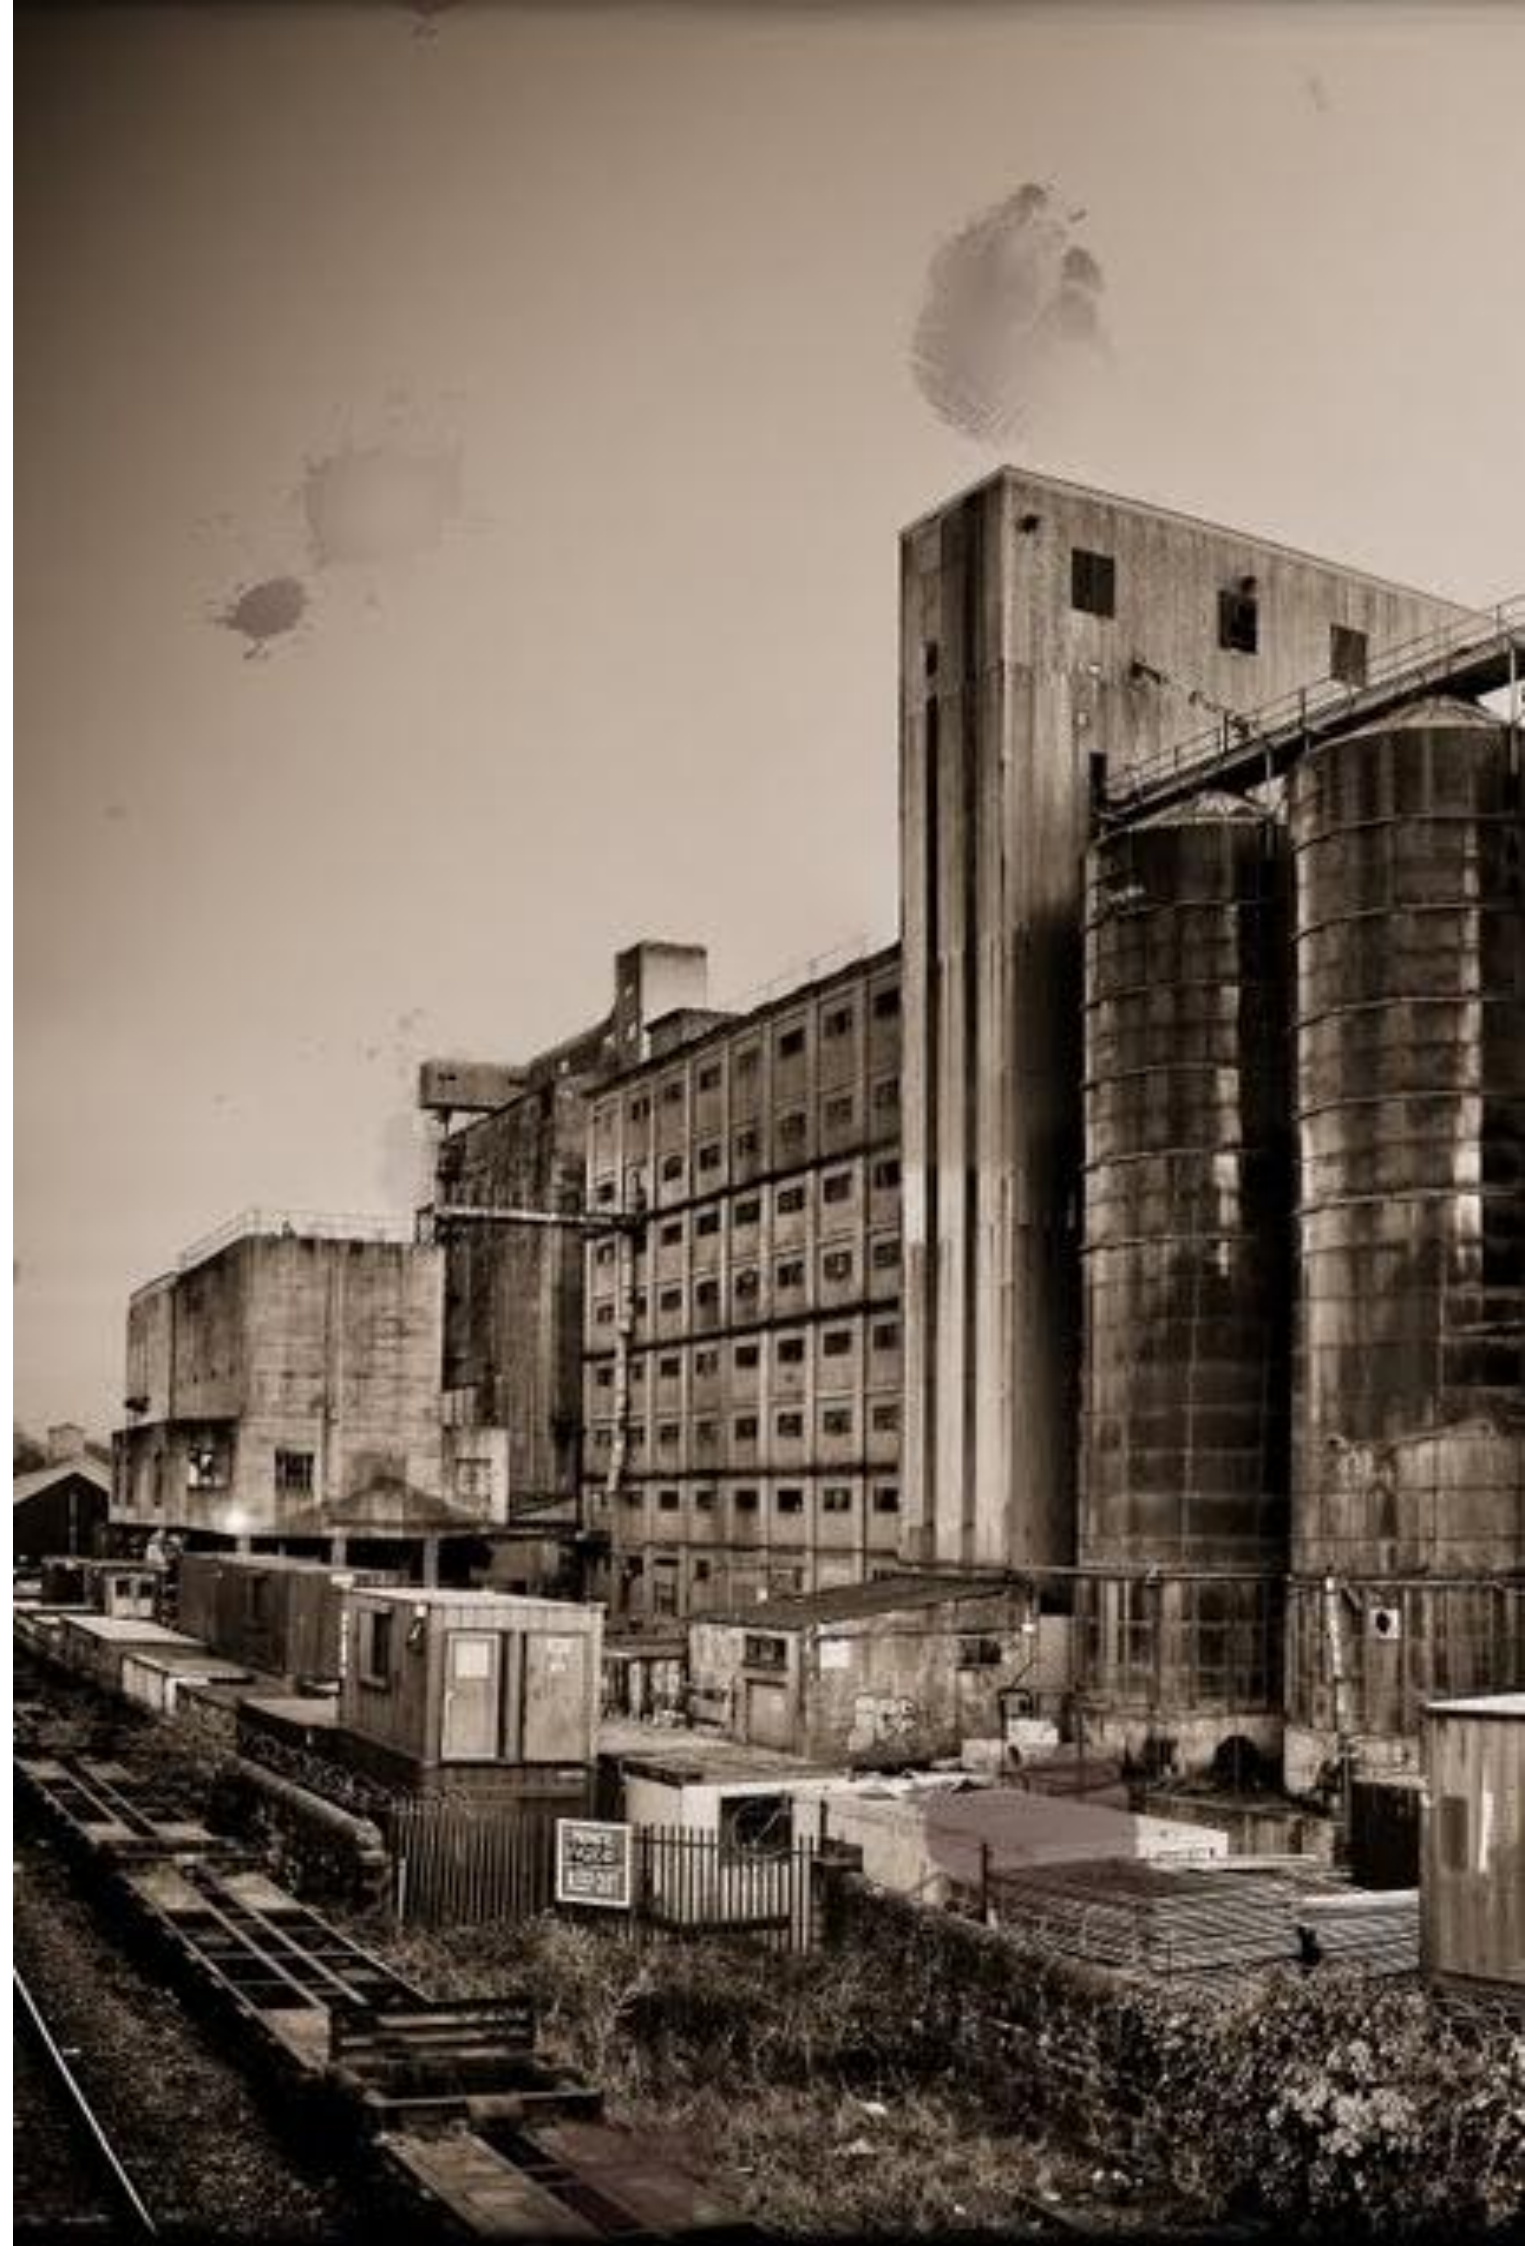
Whitfield Court

A distinguished 19th century house built for Christmas family circa 1840 with Italianate towers to entrance front, bow fronted elevation to terraced garden and top lit central Imperial staircase. Several planning applications have been proposed for this site but none have proceeded. The chimney pieces have been stolen from main rooms. Structural movement has occurred through water damage to the beam behind ground floor bow window that supports the upper floor. The property is currently for sale. This building urgently requires new uses to be identified to prevent further deterioration of its character.

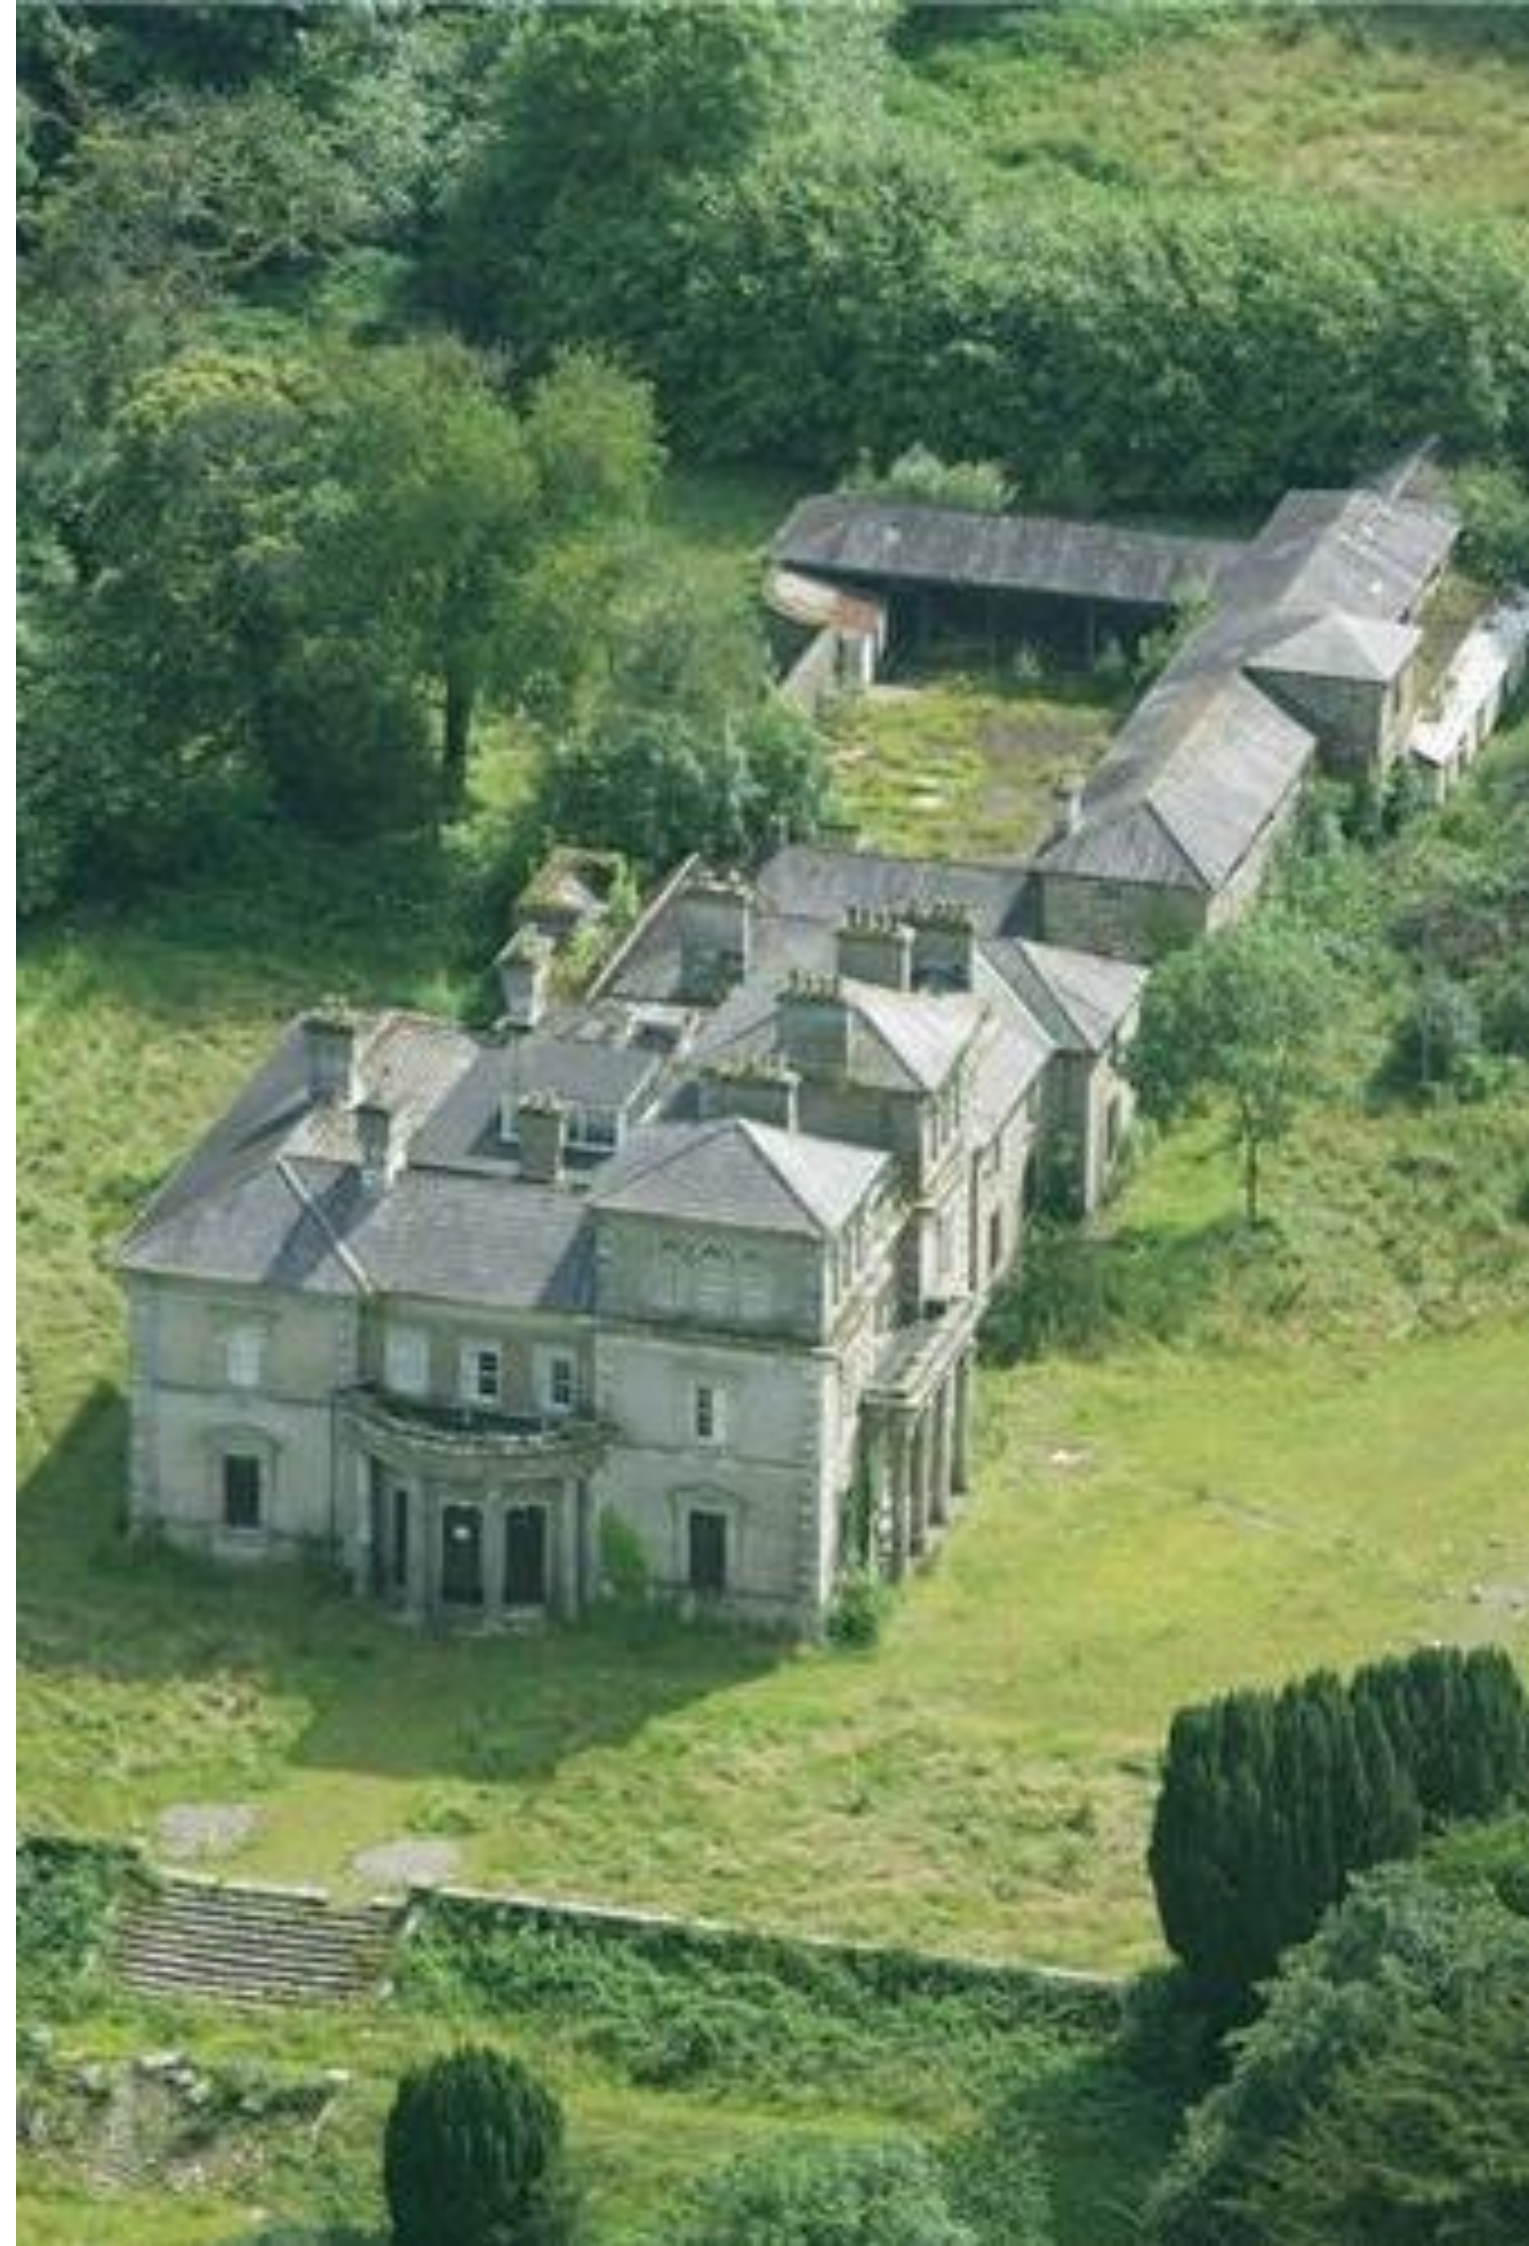
New Geneva Barracks was identified as the proposed site for a planned colony for artisan and intellectual Genevan settlers, who had become refugees following a failed rebellion against a French and Swiss government in the city. Ireland had been granted a parliament separate from London in 1782 and it was thought that the creation of the colony would stimulate new economic trade with the continent. James Gandon, who designed the Custom House, was commissioned to create a masterplan for the site overlooking the Waterford Estuary. The plans for the colony eventually collapsed, however, when the Genevans insisted that they should be represented in the Irish parliament but govern themselves under their own Genevan laws. It then became a barracks following the United Irishmen Rebellion in 1798. The complex is of significant historic importance and requires conservation works to prevent further deterioration.

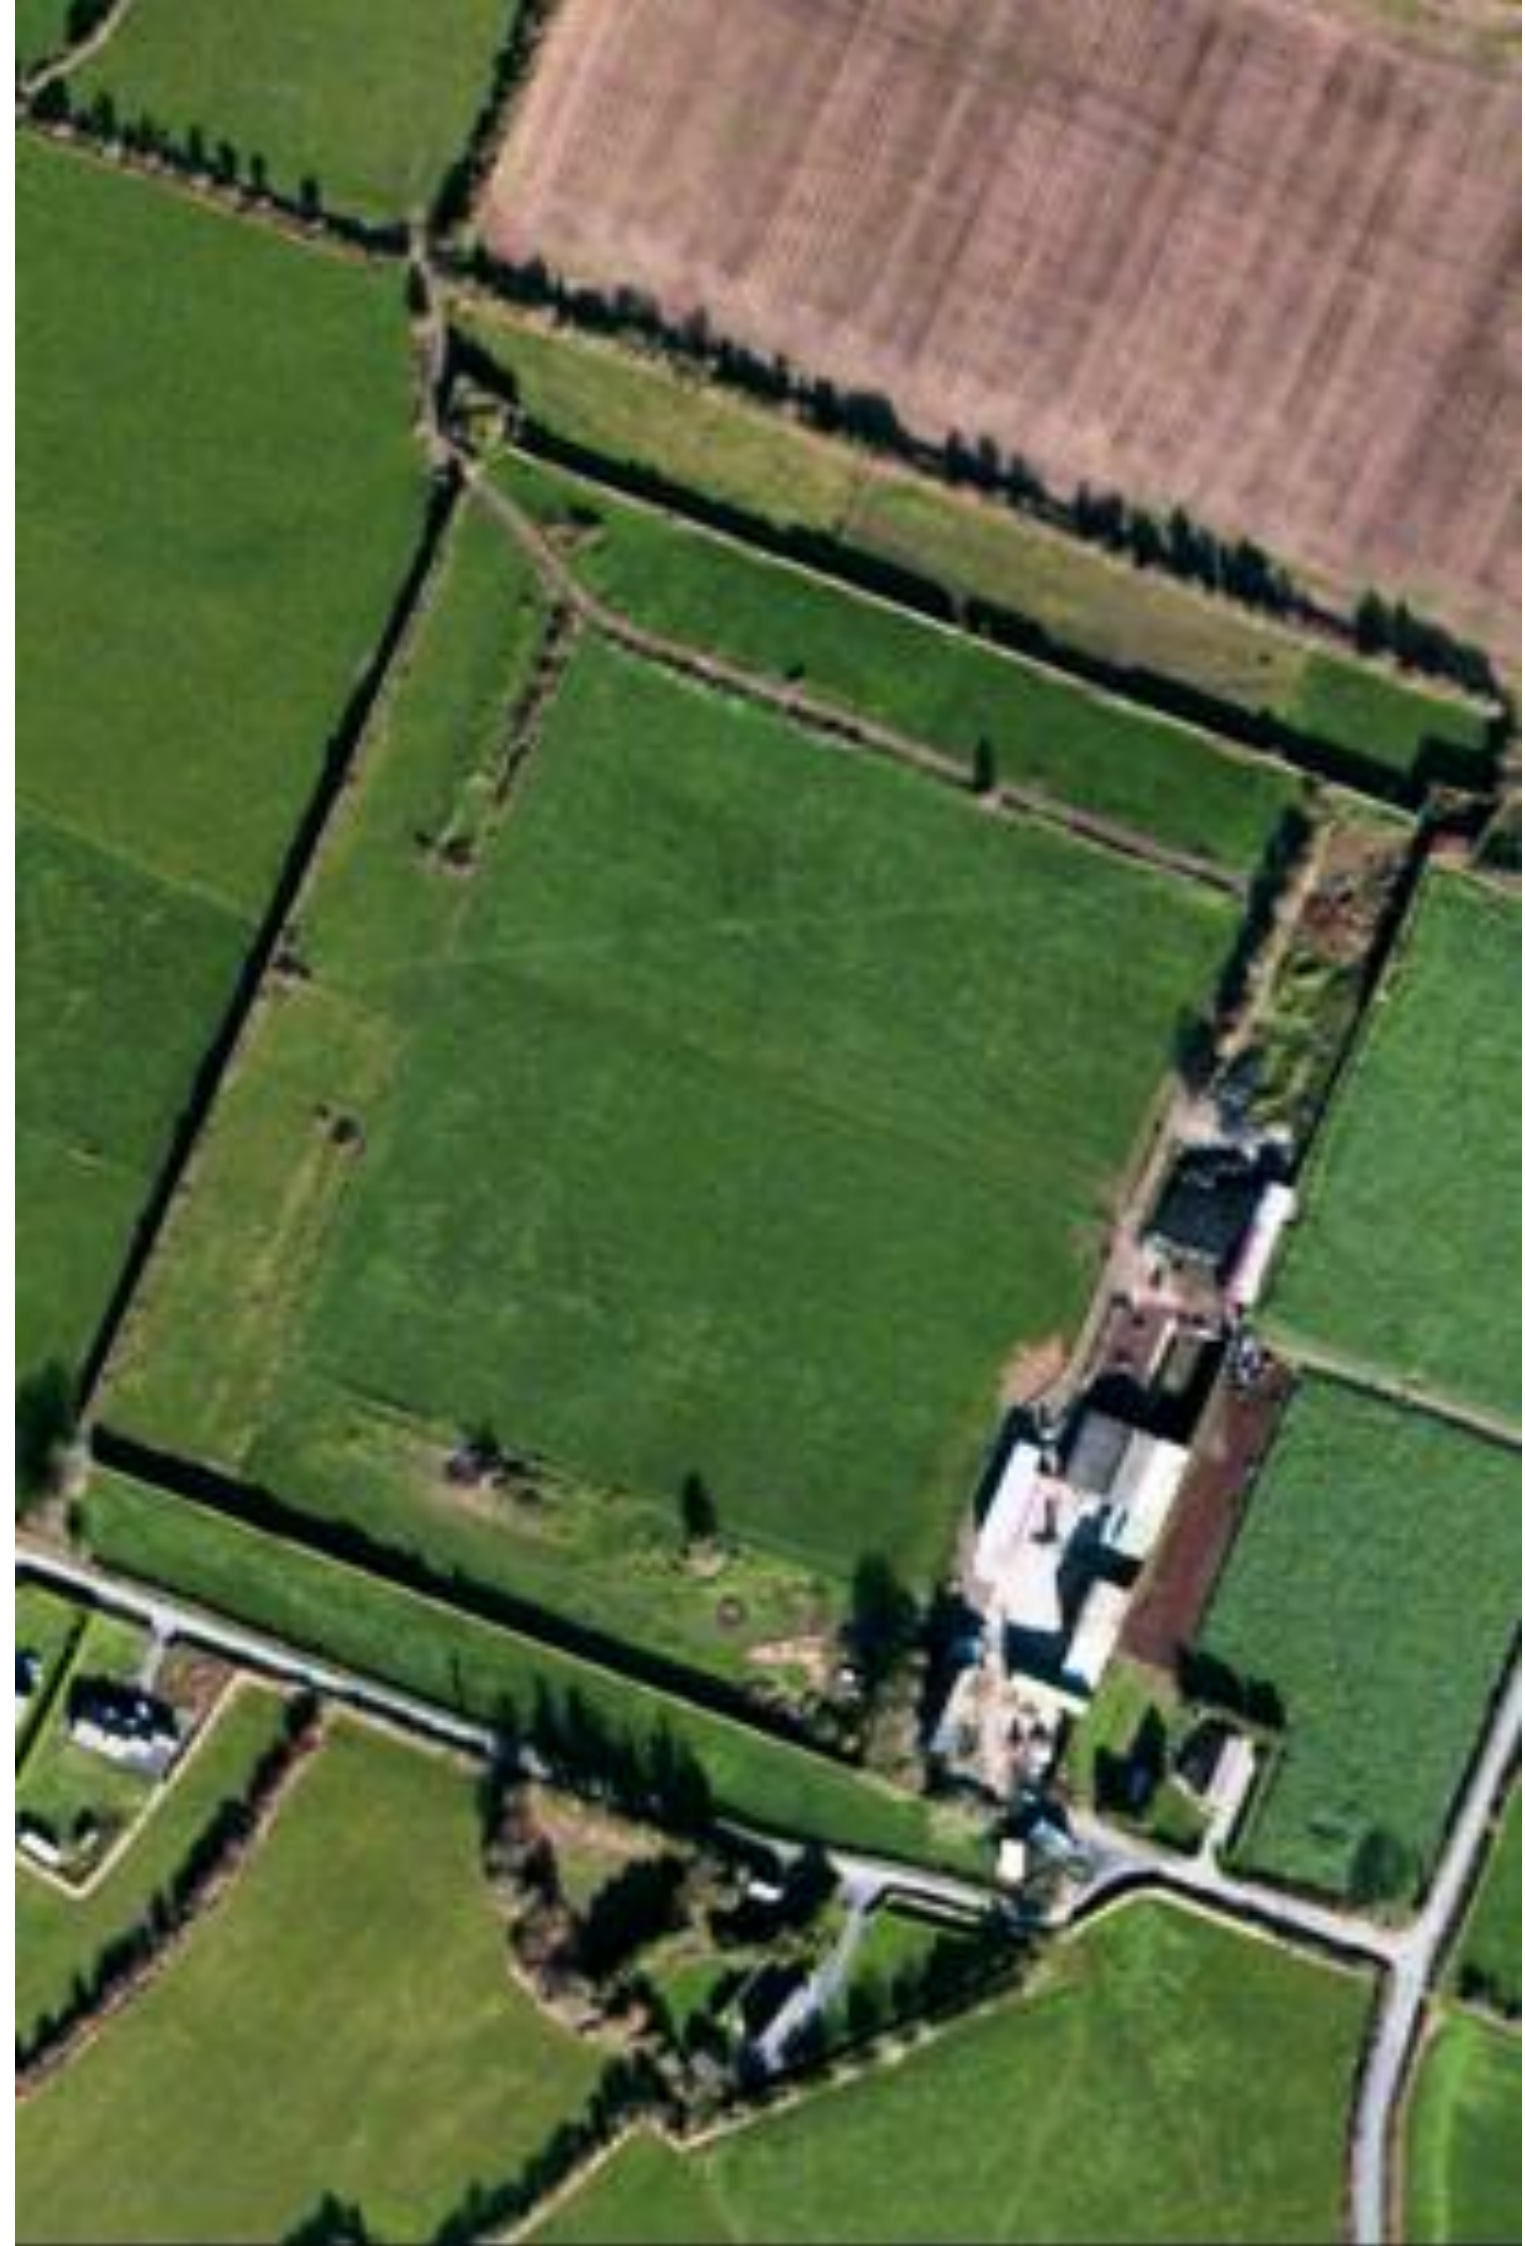
Mayfield House

Adjoining former Malcomson Factory, Portlaw. Among the richest Irish Industrialists of the mid 19th century, the Quaker Malcomsons established Portlaw as a planned industrial town, with its own leather currency. Beside both the town and the cotton mill, they created the lushly planted grounds of Mayfield, with an Italianate style house with tall central campanile and long wings, designed in the 1840s by William Tinsley of Clonmel. Elaborate interior plasterwork, much of it gilded with carved fireplaces long destroyed. The house is now a derelict shell and the grounds neglected with no plans for its future. The structure is of significant historic importance and requires conservation works to prevent further deterioration.
